Supplemental Report

Bryson v. Rough Country, LLC

Mecanica Case Number: 22-3104

Date of Collision: March 15, 2020

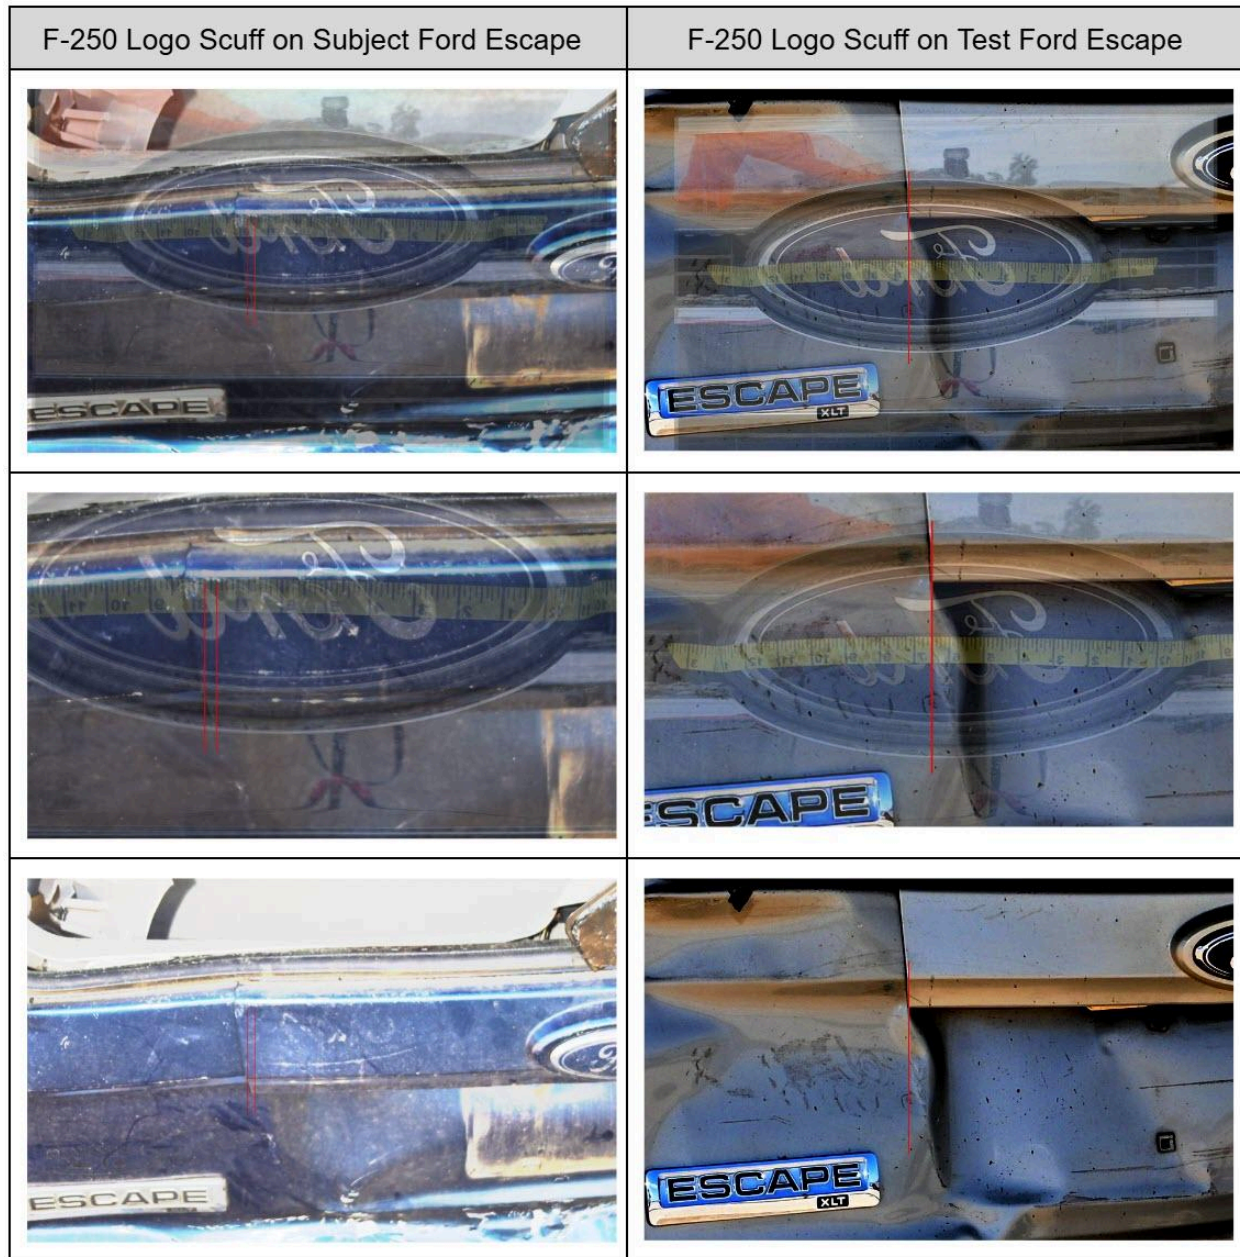
Figure 59 continues the progression of images from **Figure 58**, including the following:

- Red 'index' lines were placed on the images referencing the lower left corner of the trim panel.
- A close-up of the image with the red index lines.
- The mirror image of the Ford F-250 logo was removed, leaving the red index lines.

Figure 59: Image overlays depicting F-250 logo scuff on Ford Escape with index marks.

On the subject crash Ford Escape, the middle of the logo impression was made on the trim piece below the rear window. The left column of **Figure 59** shows the center of the F-250 logo overlay located between 1.5 to 1.75 inches toward the right of the reference point on the subject crash vehicle.

On the crash test Ford Escape, the middle of the logo impression was slightly lower than the trim panel. The right column of **Figure 59** shows the center of the F-250 logo overlay located approximately 0.5 inches toward the right of the reference point.

Utilizing the analysis documented in these images it appears that the logo scuff on the crash test Ford Escape was approximately 1 inch to 1.25 inches farther left from the longitudinal centerline than was the logo scuff on the subject crash Ford Escape. A portion of this difference may be explained by the rear hatch displacement to the right as shown in the point clouds and photos.

16. Analysis of the F-250's front logo scuff on the rear of the Escape in the crash test indicates the centerline of the Ford was approximately 1 to 1.25 inches to the left of the logo scuff on the subject crash Ford Escape when the scuffs were made.

17. The location of the logo scuff on the test Escape was lower, relative to the hatch window, than the logo scuff on the subject crash Escape.
18. The F-250's front logo scuff on both Ford Escapes discussed are on complex 3-dimensional surfaces. These surfaces were distorted and displaced during the respective crashes and it is unknown exactly when the scuffs were made. In addition, some of the difference in logo scuff location might be explained by the rear hatch displacement to the right shown in scan files and photos.

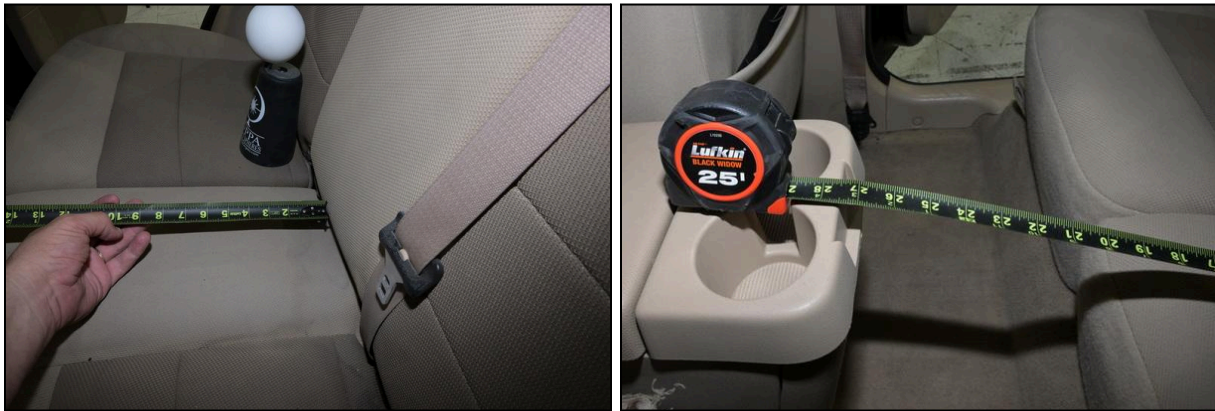
A measurement was made from the aft edge of the center console to the lower middle of the rear seatback. **Figure 66** depicts this measurement in the exemplar Ford Escape and **Figure 67** depicts this measurement in the test vehicle. This part of the rear seatback was displaced forward approximately 10.5 inches. Note that this measurement also includes more of a vertical component in the exemplar vehicle, thus the actual displacement would be slightly less.

Figure 66:- Measurement to lower middle of rear seatback in exemplar Ford Escape.

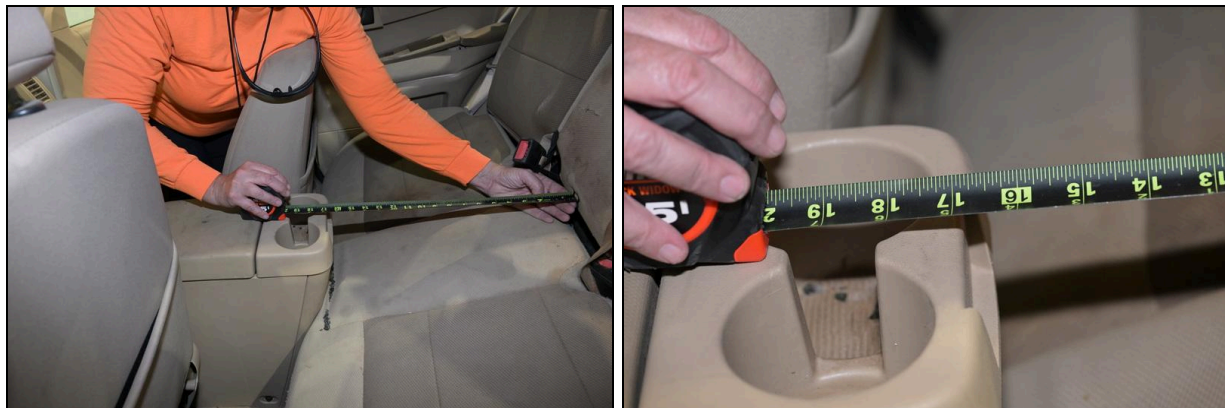
Figure 67: Measurement to lower middle of rear seatback in test Ford Escape.

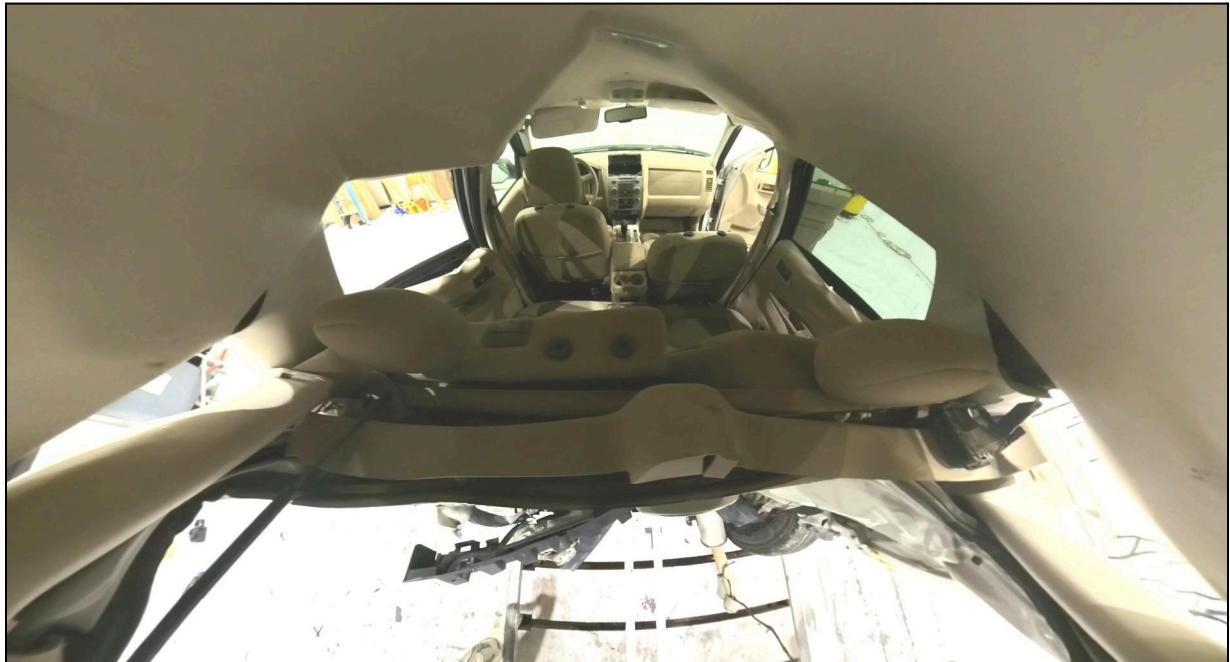
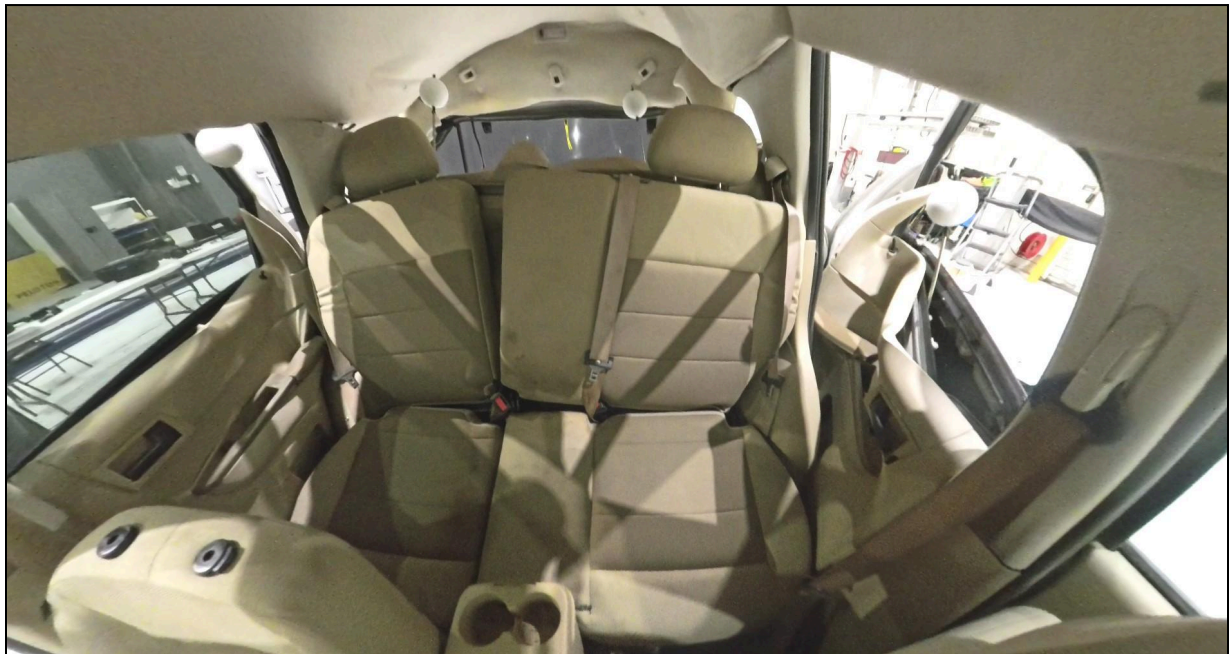
Figure 68 through Figure 70 depicts still images extracted from a 360 video of the seatback area of the test Ford Escape. It can be seen that the seatback is displaced and distorted. In addition, these images show that the interior of the vehicle hatch made contact with the aft portion of the rear seatback.

Figure 68:- Still image depicting the vehicle rear hatch and rear seatback.

Figure 69: Still image depicting the vehicle interior and rear seatback.

Figure 70: Still image depicting the vehicle rear hatch and rear seatback.
